Doc.Nº: NGR-PDS-CGS-C-139

NON CONFORMANCE REPORT

ANNEX A TO NCR-PBS-CGS-C-139

PDS: Evaluation of maximum temperature with updated PDS dissipation

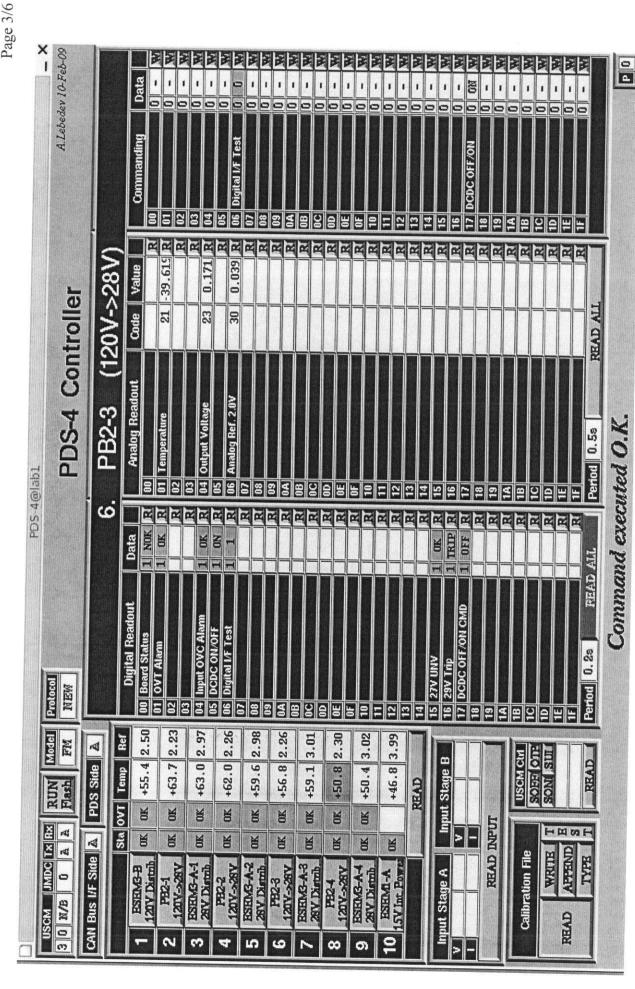
Fig. 1: PDS GUI screenshot after PB2-3 failure occurrence

During 5th cycle HOT plateau, with Side A of PDS unit switched ON, PB2-3 board has been found in OFF condition while performing unit dissipation test at 113V input (ref. ¶10.3.1.8.2 of "AMS02-PDS PFM FULL FUNCTIONAL TEST PROCEDURE" PDS-PR-CGS-006 Is. 2). Symptoms of the malfunction were (see Fig. 1):

- Absence of 28V output voltage at all outlets of ESEM3A-3 board (which is powered by PB2-3)
- All board analogue telemetries to low range (around 0V -equivalent to few digital counts)
- All board digital statuses to "High" level (which results in non consistent indications, e.g. board is commanded OFF – though no such command has been sent – but status is ON)

Above described situation is only compatible with complete switch OFF of the aux. DC/DC converter mounted on PB2; in this case, all board internal circuits are not supplied (and therefore not functional) and, as a result, no analogue telemetry is available (0V is read by CAN bus board mounted A/D converter also for "Analog Ref. 2.0V" which is directly related to aux. DC/DC supply voltage) while the pull-up resistor, mounted on CAN bus at digital status line, forces an high state (which is read and interpreted as "NOK" by CAN bus board).

As failure of aux. DC/DC converter board is latched, the only way to restore nominal functionality is to remove aux. DC/DC inlet power; a 120V ON/OFF/ON cycle has to be performed.

After a 120V ON/OFF/ON cycle, unit functionality has been restored and nominal configuration (see *Tab. 1*) could be commanded. Then input voltage has been set to nominal voltage for continuation of functional verifications.

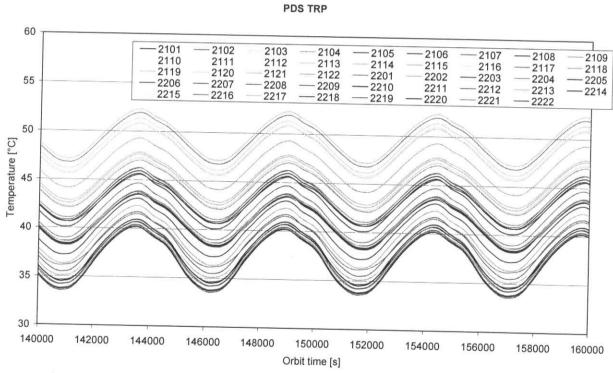
Thermal dissipation of PDS has been updated, according to data collected during the qualification test. Actual thermal dissipation obtained during testing is globally 310W vs the former 365W used for the design analyses.

From the previous analyses reported in AMSTCS-TN-CGS-004 MAIN AND TRACKER RADIATOR THERMAL ANALYSIS REPORT Tmax at TRP was 52.3°C

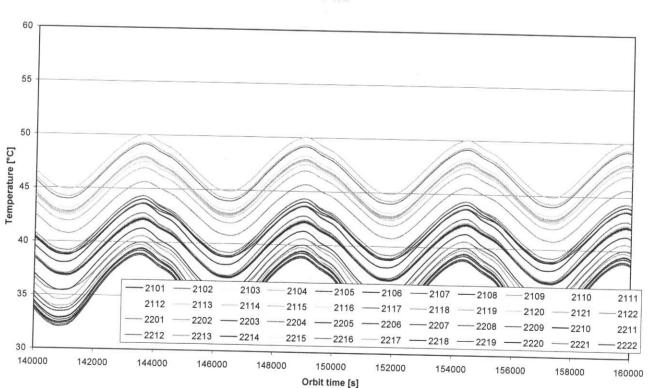
The New Tmax at PDS TRP is 50.0°C on node 2115

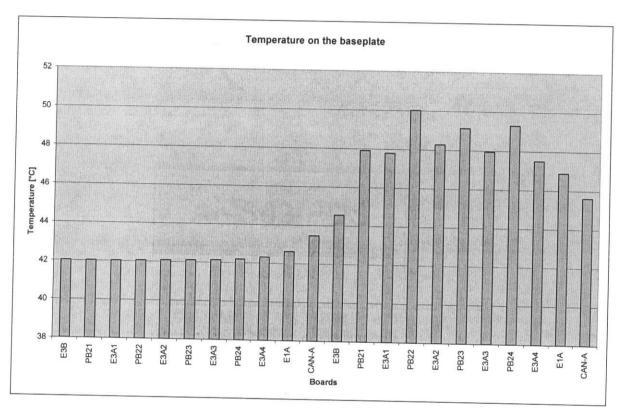
Temperature spatial distribution on the baseplate, board side (picked @ time with the higher temperature):

The maximum instantaneous temperature calculated in the worst hot case with the maximum PDS dissipation of 310W is 50°C, and is below the maximum tested temperature of 50.3°C to which the PDS unit is able to continuously operate with a 113 V input (see annex B).

Considering the margins taken in the worst hot case definition, the margin attained is sufficient to guarantee the correct operation of PDS on orbit without operational restrictions in nominal configuration.
